Mobile Intel[®] Pentium[®] II Processor Specification Update

Release Date: July 2001

Order Number: 243887-032

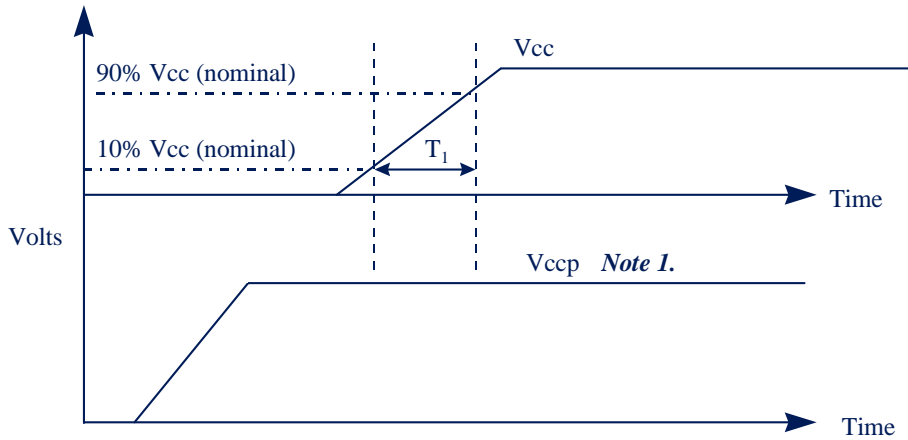
Figure 1. V_{CC}/V_{CCP} Timing Requirements (Mobile)

Problem: The processor uses the PWRGOOD signal to ensure that no voltage sequencing issues arise; no pin assertions should cause the processor to change its behavior until this signal is asserted, when all power supplies and clocks to the processor are valid and stable. However, if V_{CC} ramps up before V_{CCP} , it will cause the processor to enter an invalid state.

Implication: If this erratum occurs, the system may boot normally however, the L2 cache may not be initialized.

Workaround: For Mobile Pentium II processors, ensure that V_{CC} ramps after or with the L2 cache IO voltage (V_{CCP}). If V_{CCP} ramps after the V_{CC} , a delay circuit can be placed on the core V_{CC} to ensure that V_{CC} ramps at the same time or after V_{CCP} as shown below in Figure 1.

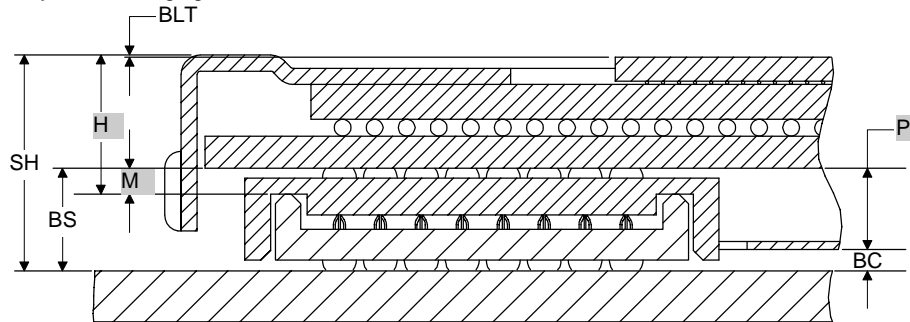
Figure 5.6. Cross Sectional View with Vertical Dimensions

B1. Misabeled Vertical Dimension Parameters

Figure 5.6 in the *Mobile Pentium® II Processor at 233 MHz, 266 MHz, and 300 MHz* datasheet should be replaced by the following figure:

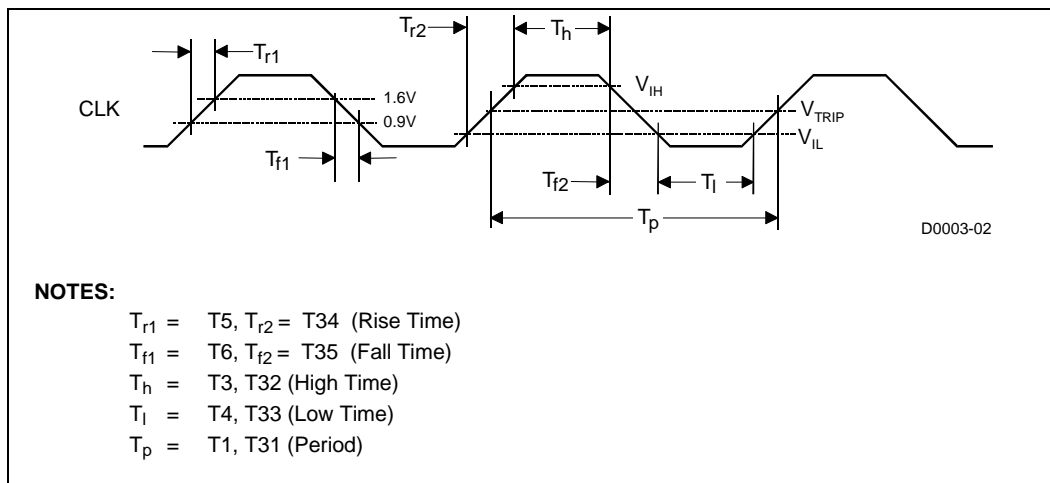
Figure 3.3 Generic Clock Waveform

B14. Generic Clock Waveform Figure

Figure 3.3 in *Mobile Pentium® II Processor in Mini-Cartridge Package at 366 MHz, 333 MHz, 300PE MHz, and 266PE MHz* datasheet (Order Number 245108), and the *Mobile Pentium® II Processor in BGA Package at 366 MHz, 333 MHz, 300PE MHz, and 266PE MHz* datasheet (Order Number 245106) has been updated. The following figure is to replace the ones in the above documents.
